# Hazard Assessment of Lithium Ion Battery Energy Storage Systems

*FINAL REPORT*

© February 2016 Fire Protection Research Foundation

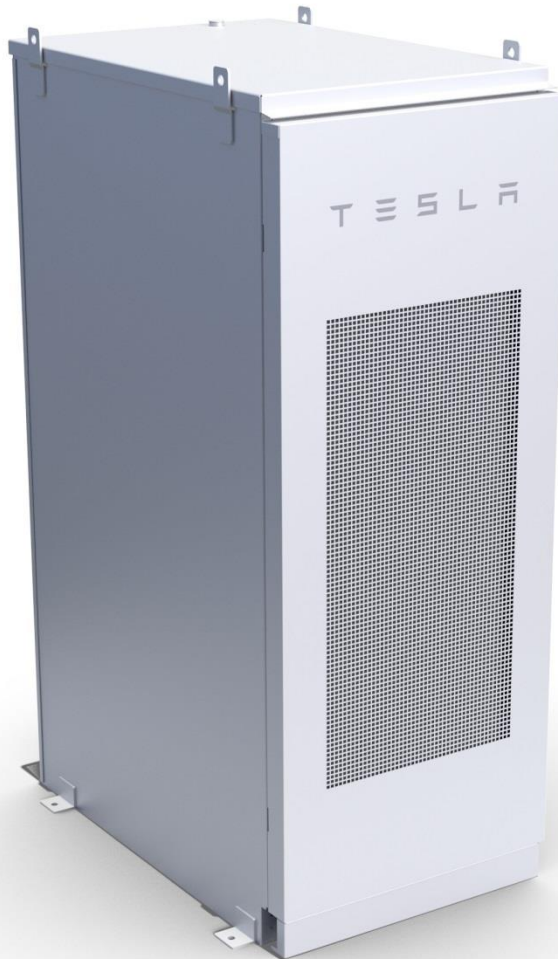
Figure 5 Single standalone Powerpack (100 kWh commercial ESS)

This section provides an overview of the Powerpack (a 100 kWh commercial ESS) utilized for this testing program. The Powerpack can be a single standalone unit, as shown in Figure 5, or installed side by side with multiple Powerpacks if additional storage capacity is desired, as shown in Figure 6.

The Powerpack was positioned on a noncombustible surface similar to its intended end use for an outdoor installation on a concrete pad, as shown in Figure 5. The test instrumentation, including thermocouples (TCs), heat flux gauges (HFGs), pressure transducers, gas sampling, data acquisition, weather meter, and cameras were positioned around the Powerpack as illustrated in Figure 11. In addition, a propane burner, further described in Section 5.1.2, was placed to the right side of the Powerpack, allowing for direct flame impingement on the exterior of the Powerpack cabinet.

The Powerpack was positioned on a noncombustible surface similar to its intended end use installation on a concrete pad, as shown in Figure 5. The test instrumentation, including thermocouples (TCs), pressure transducers, gas sampling, data acquisition, weather meter, and cameras were positioned around the Powerpack as illustrated in Figure 16. In addition, heater cartridges utilized to force the individual batteries into thermal runaway, further described in Section 5.2.2, were positioned inside pod 6 (the initiator pod).

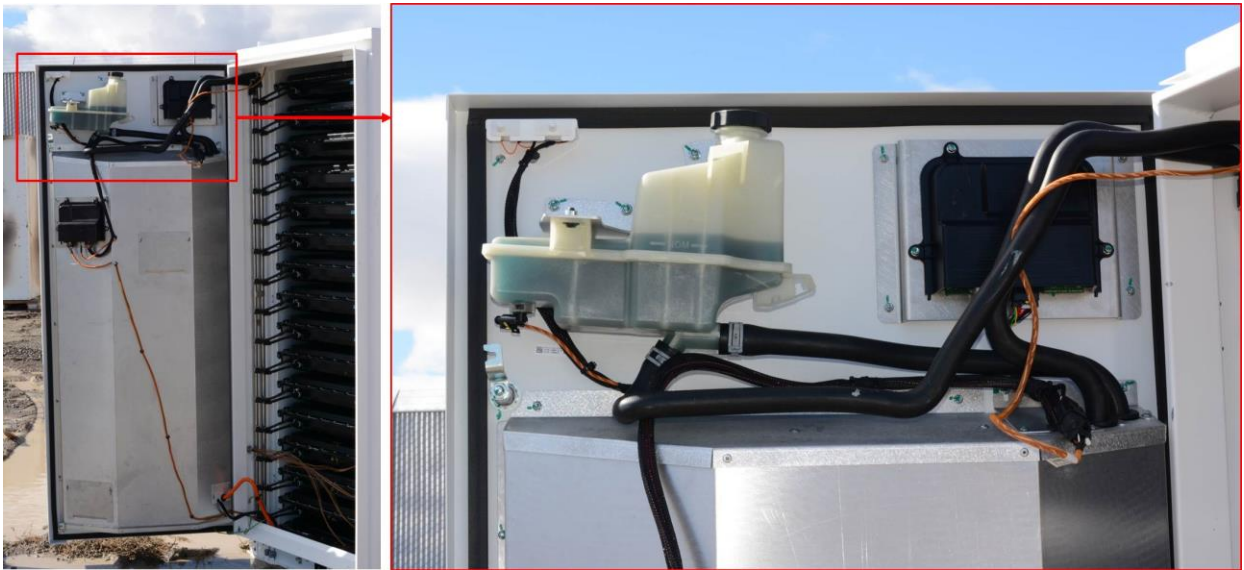
Figure 9 Powerpack thermal door (left) and close up of the refrigerant (right)

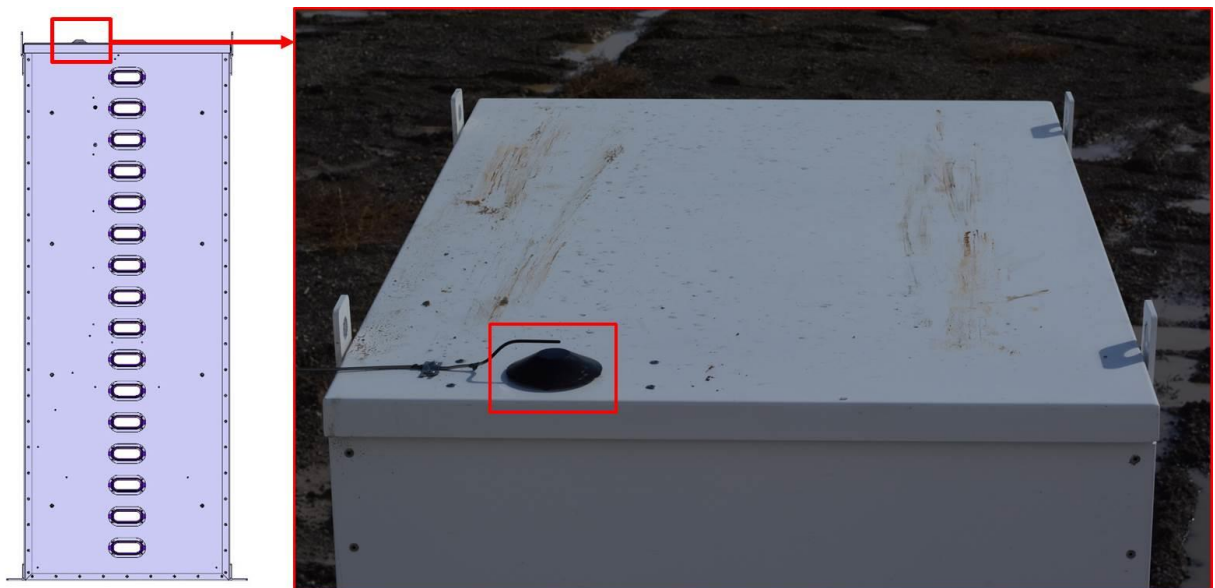
Figure 10 Illustration of the Powerpack exhaust vent (left) and an image of the vent at the top of the Powerpack (right)

The Powerpack was designed for commercial installations. Within the Powerpack, Li-ion cells are contained within energy storage pods. The energy storage pods are housed inside a 52-inch long by 38-inch wide by 86-inch high steel cabinet. The total weight is 3,970 pounds. The front door of the Powerpack cabinet provides access to each of the 16 energy storage pods, as shown in Figure 8, and contains equipment designed to thermally cool the pods. The liquid cooling system pumps a 50% water / 50% ethylene glycol mixture to each of the 16 energy storage pods, as shown in Figure 9. The coolant pumps, reservoirs, and associated fans and radiators are mounted and contained within the front door of the Powerpack. A refrigerant system using 400 grams of R134a further cools the ethylene glycol and is also mounted on the front door of the Powerpack. The back of the energy storage pods connect to an exhaust manifold at the rear of the Powerpack that has a vent at the top, as shown in Figure 10.

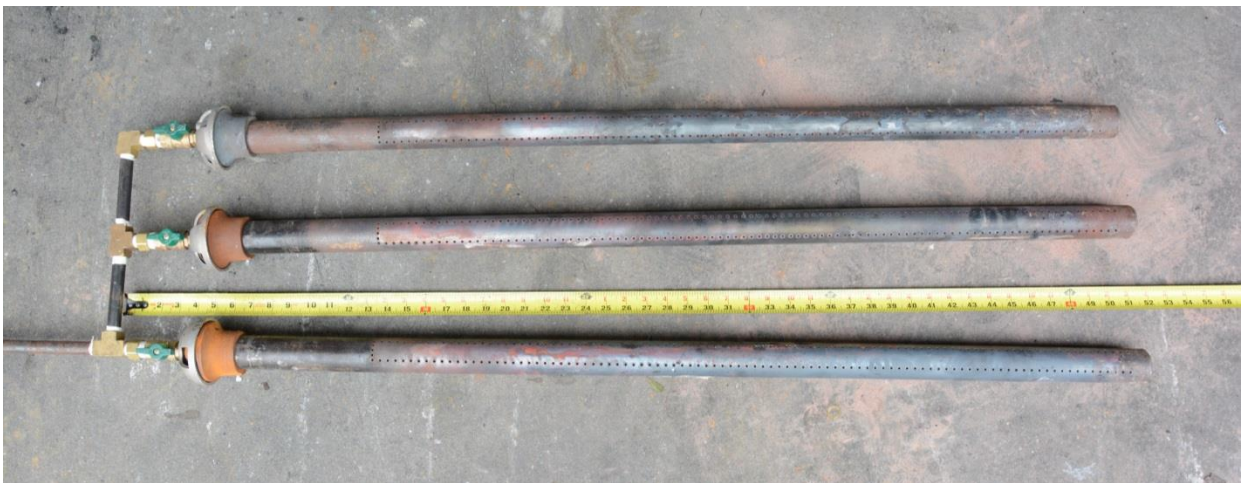
Figure 12 Burners utilized for testing

Each burner was 1.25 inches in diameter and 49 inches long and consisted of two rows of 2 mm orifices drilled at an angle 45 degrees apart. The orifices extended for 36 inches, spaced approximately 5 mm apart. The three burners were installed inside a five sided, 36 by 36 inch by 8 inch steel shell, with a steel mesh covering the opening to increase the amount of radiative heat load from the burner assembly to the exterior wall of the Powerpack enclosure. The burner assembly was positioned against the right side of the Powerpack cabinet to allow for direct flame impingement on the exterior of the unit, as shown in Figure 13. .

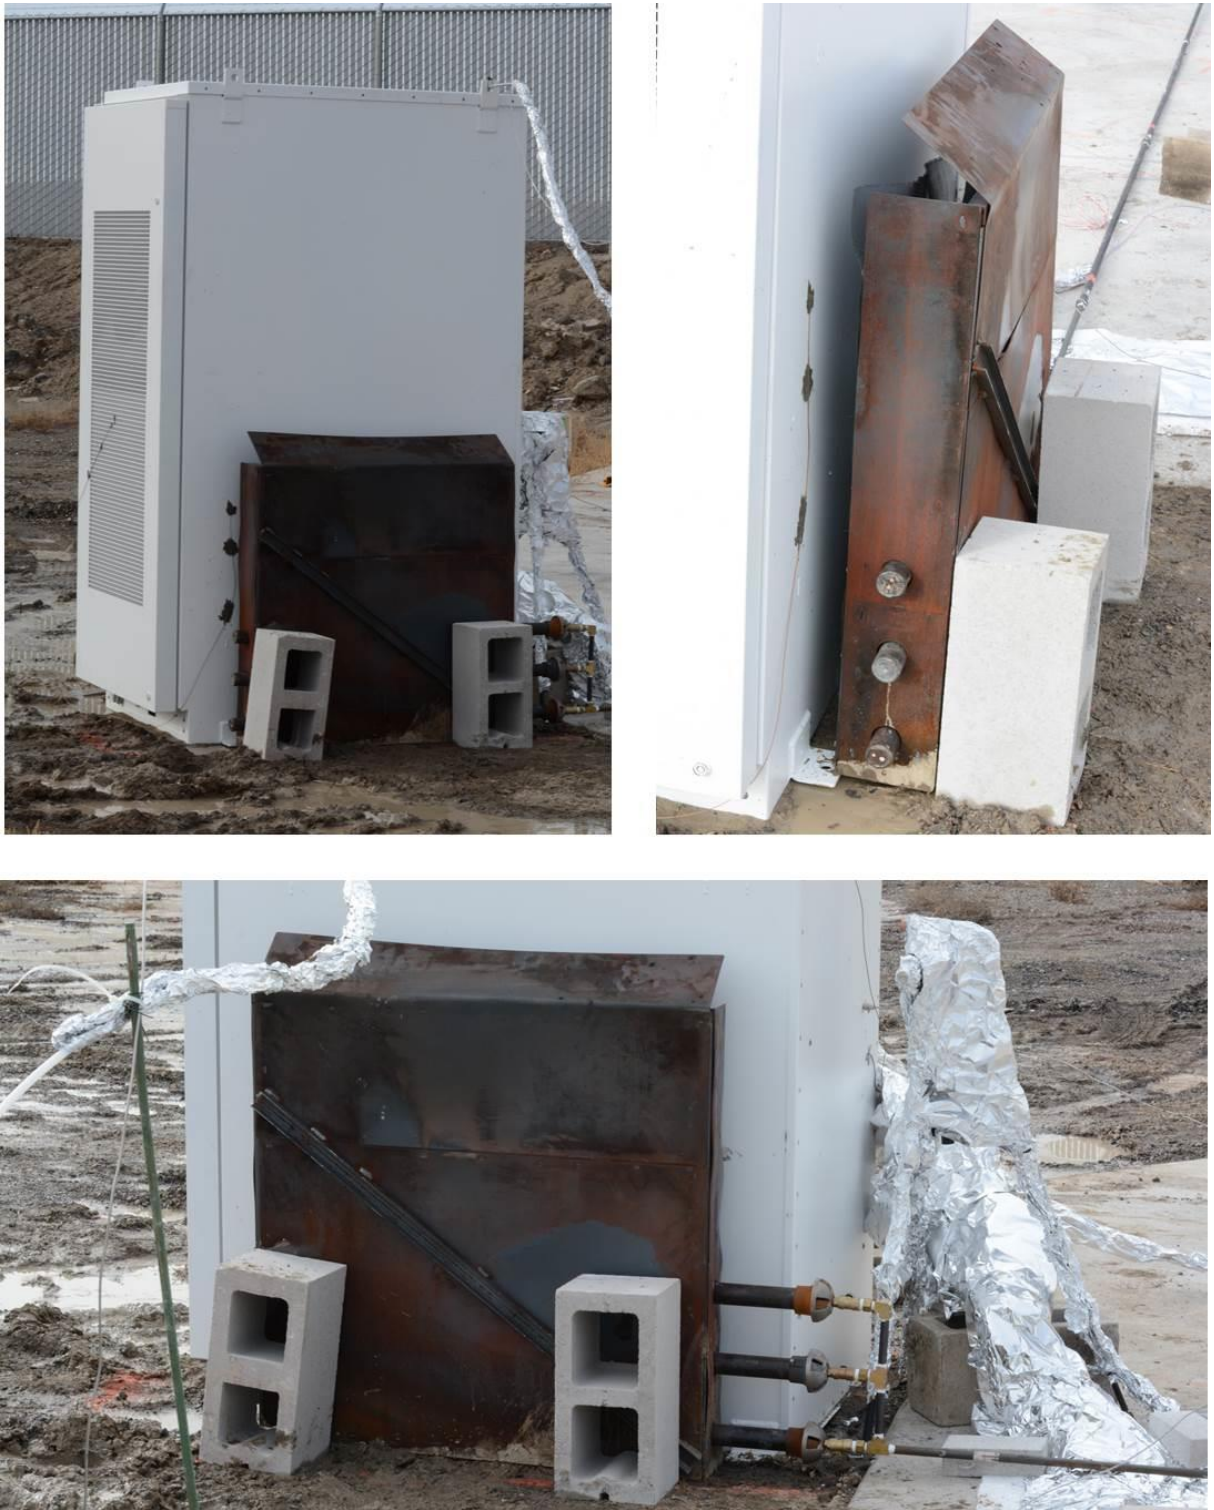
Figure 13 Burner assembly and positioning

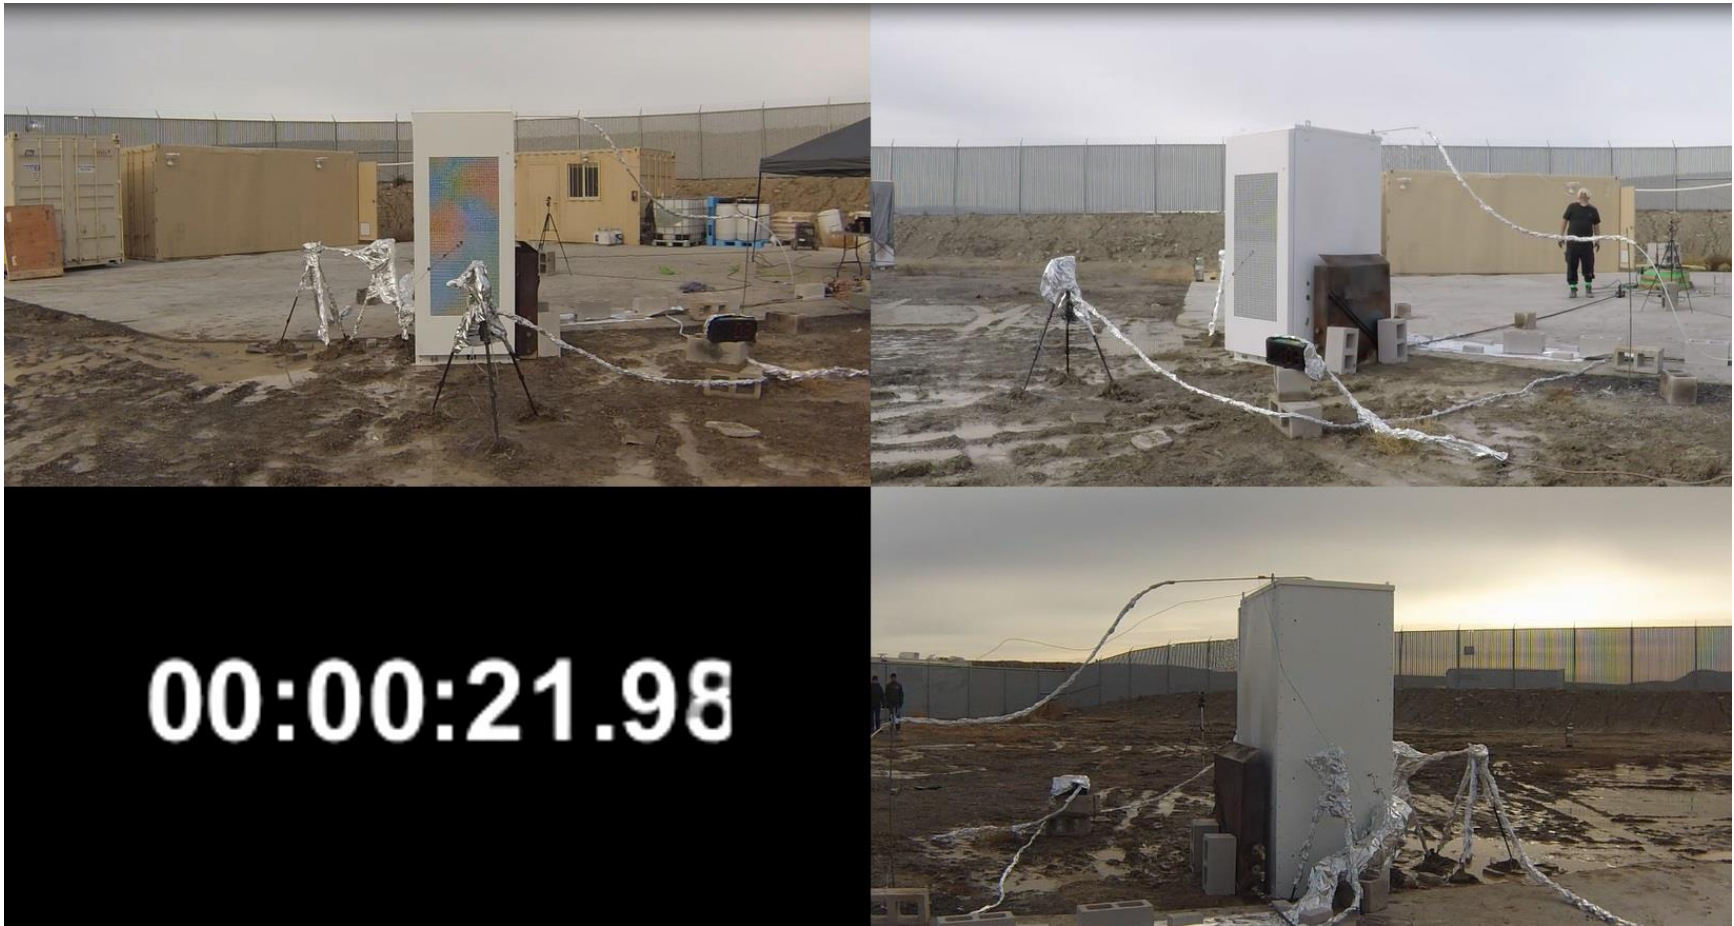
Figure 21 External test screenshot: start of test, burners "ON"

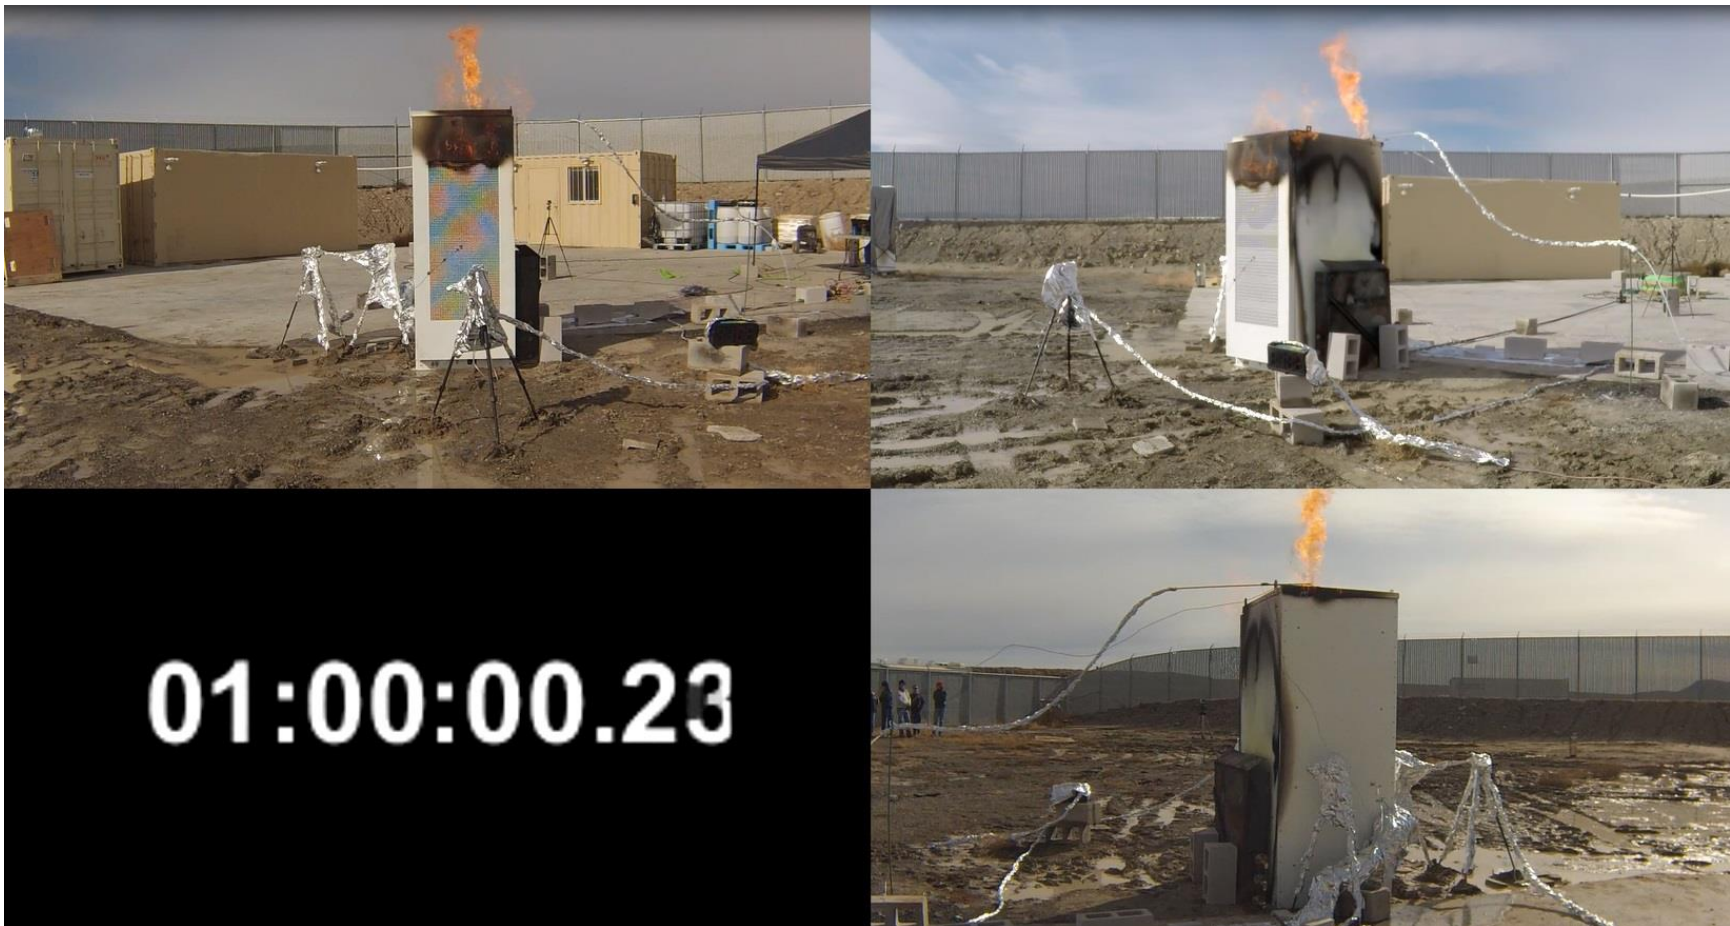
Figure 22 External test screenshot: test time = 1 hour, fire emanating from the front door and exhaust vent, pops consistent with battery cell thermal runaway heard steadily, burners turned "OFF"

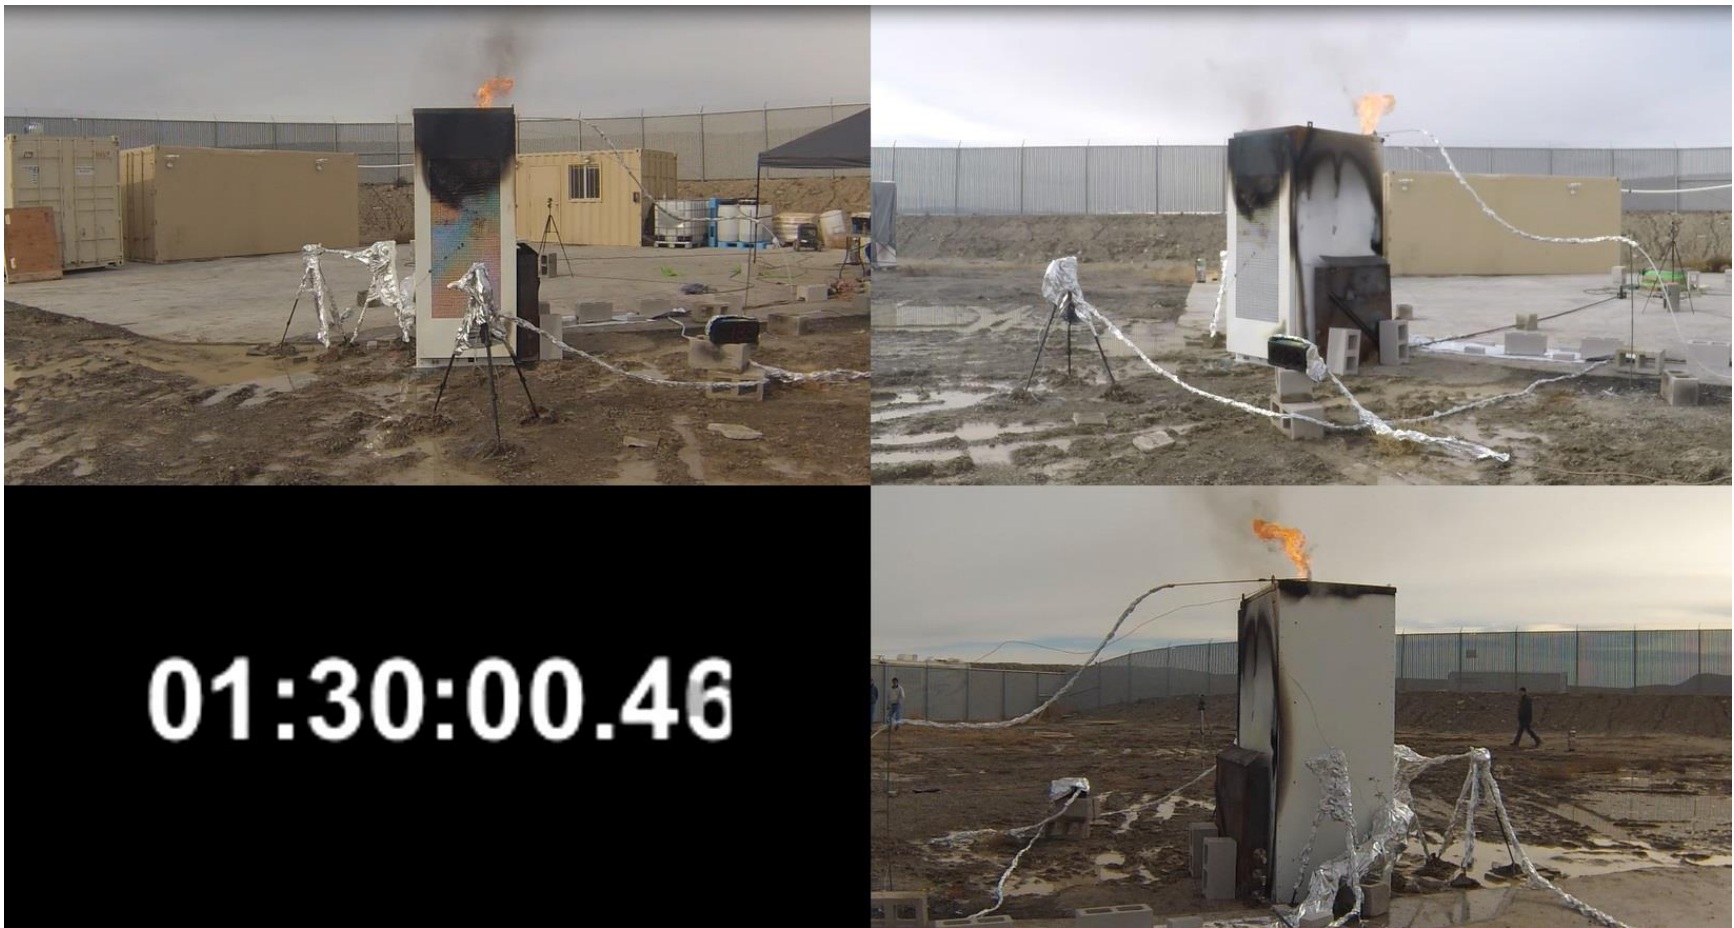
Figure 23 External test screenshot: test time = 1 hour 30 minutes, flames at front door and exhaust vent intermittently decreasing in intensity

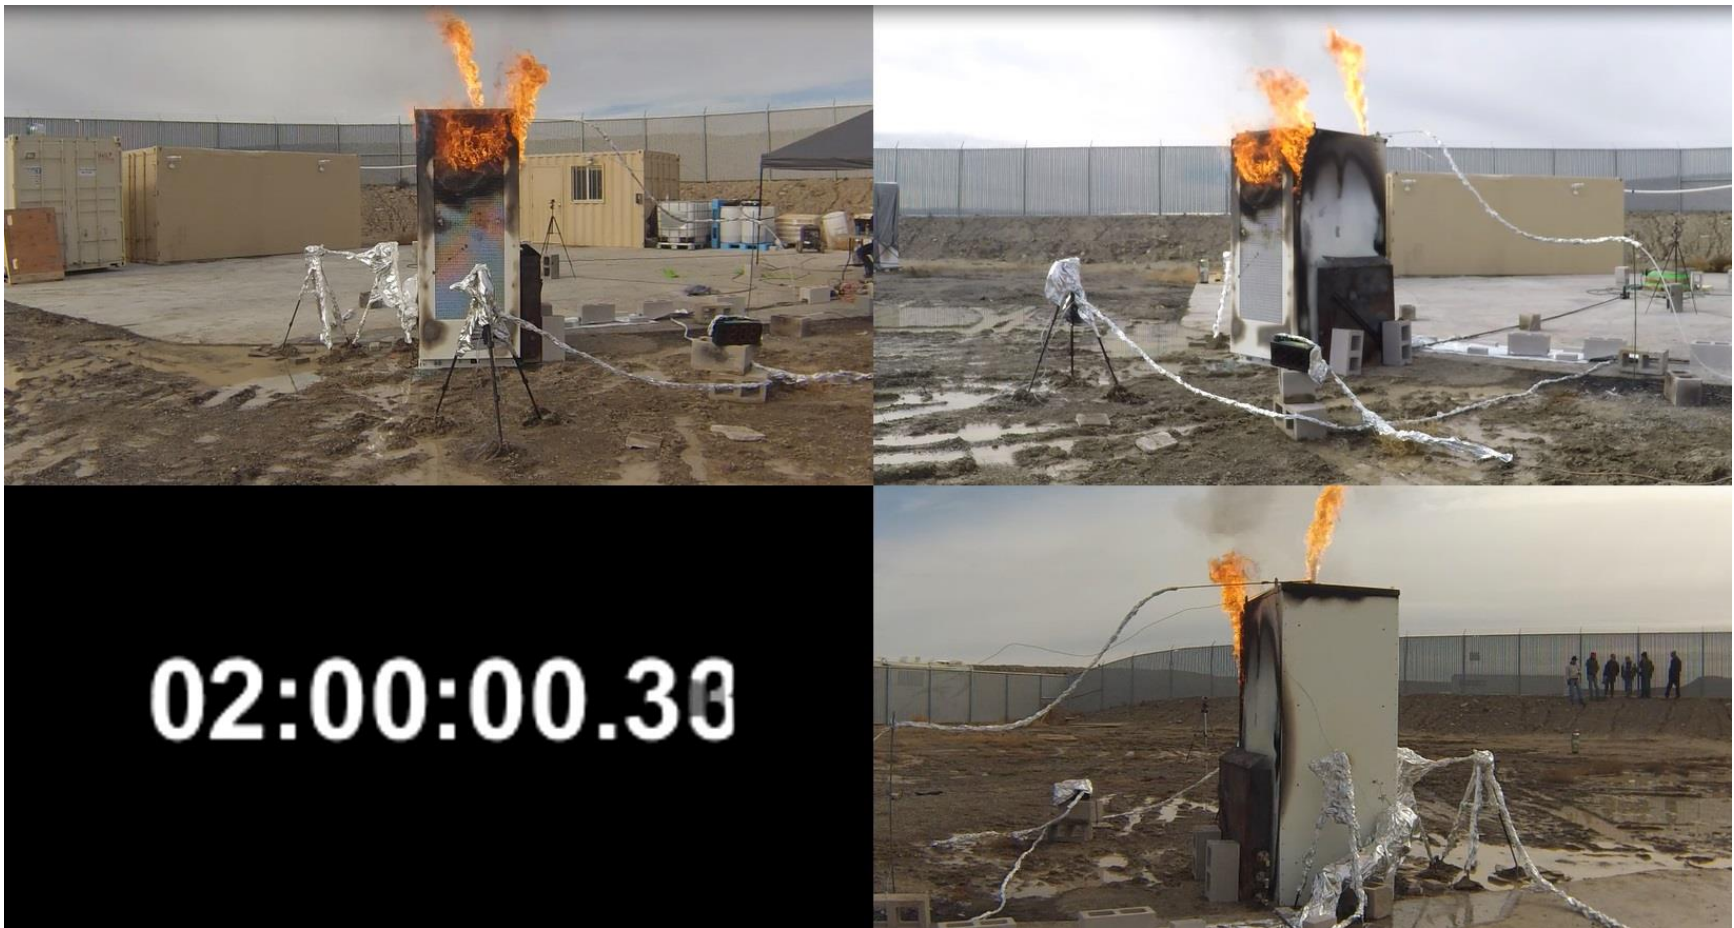
Figure 24 External test screenshot: test time = 2 hours, fire inside the Powerpack intensifying

2:00:00	Fire inside Powerpack intensifying
2:30:00	Fire inside Powerpack steady
2:33:30	Fire inside Powerpack decreasing in intensity
3:00:00	Fire insides subsiding, weak flames observed out the front door and exhaust vent

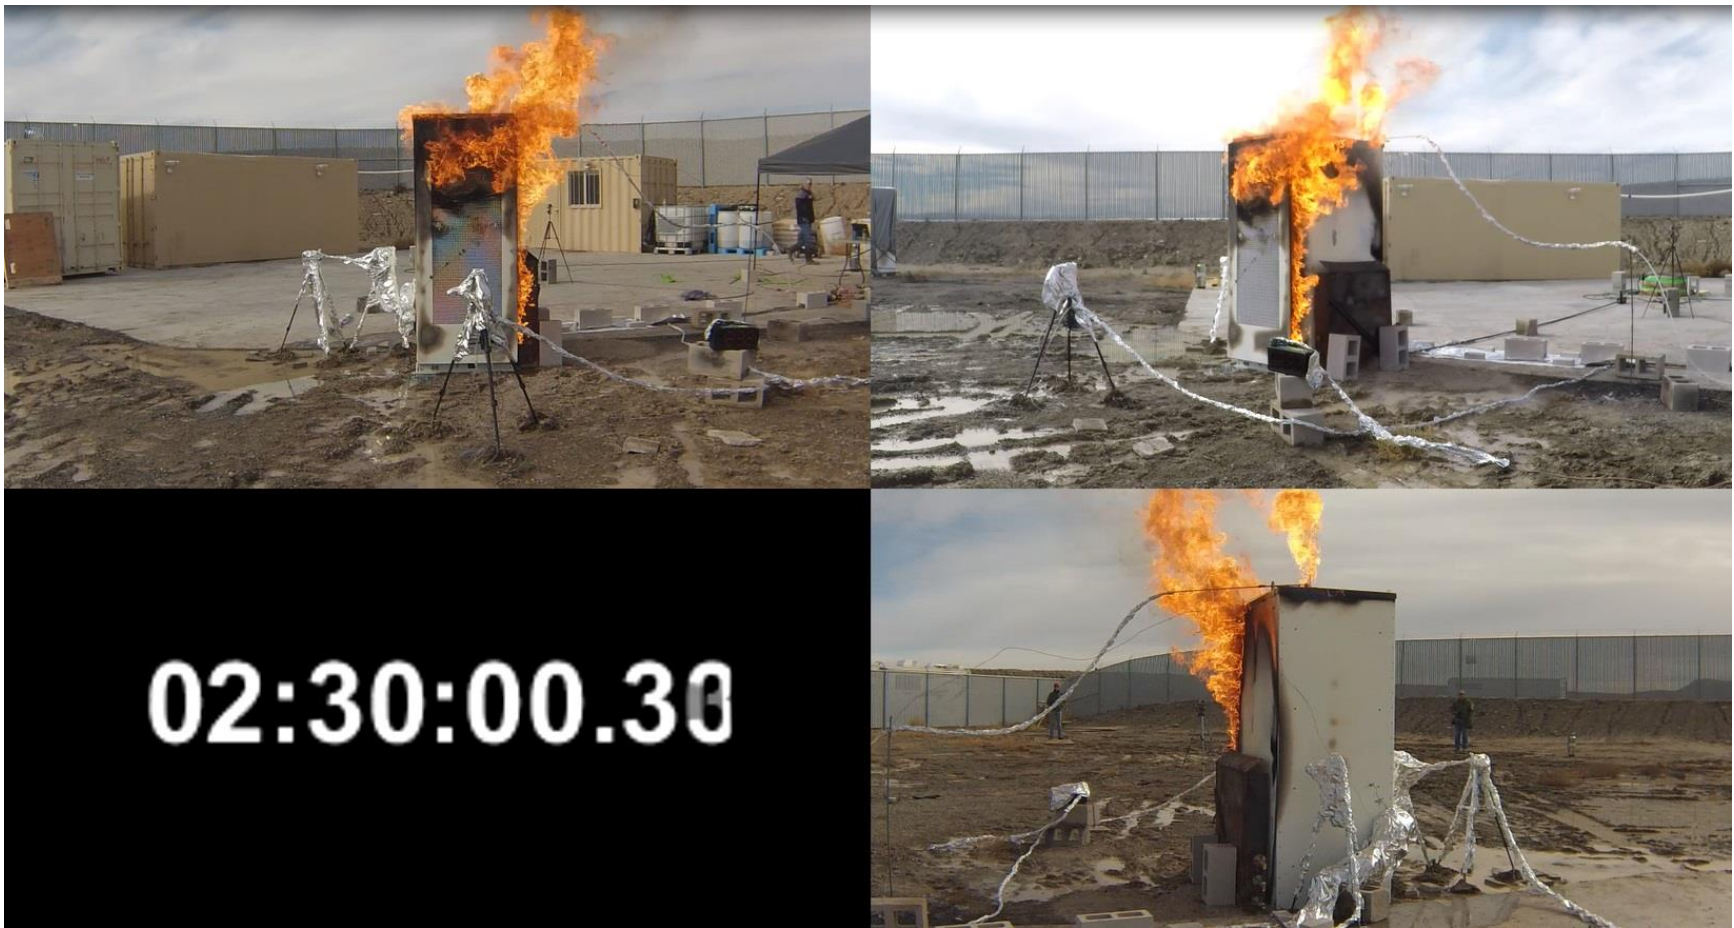
Figure 25 External test screenshot: test time = 2 hours 30 minutes, fire inside the Powerpack intensifying

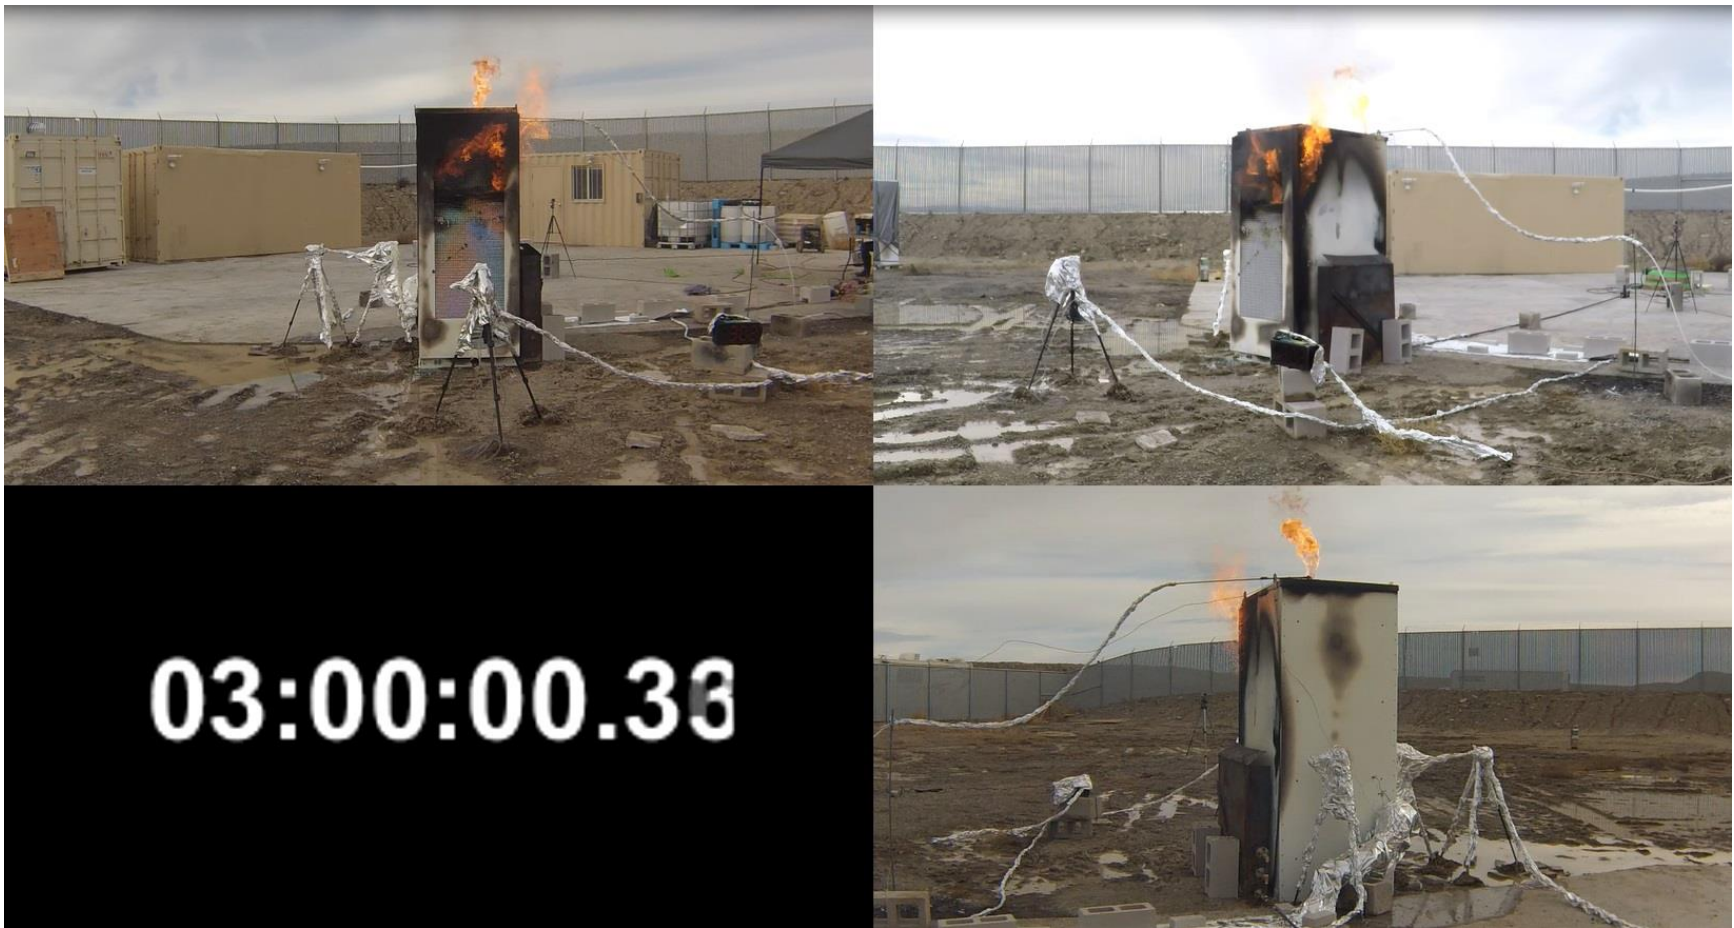
Figure 26 External test screenshot: test time = 3 hours, fire inside the Powerpack subsiding

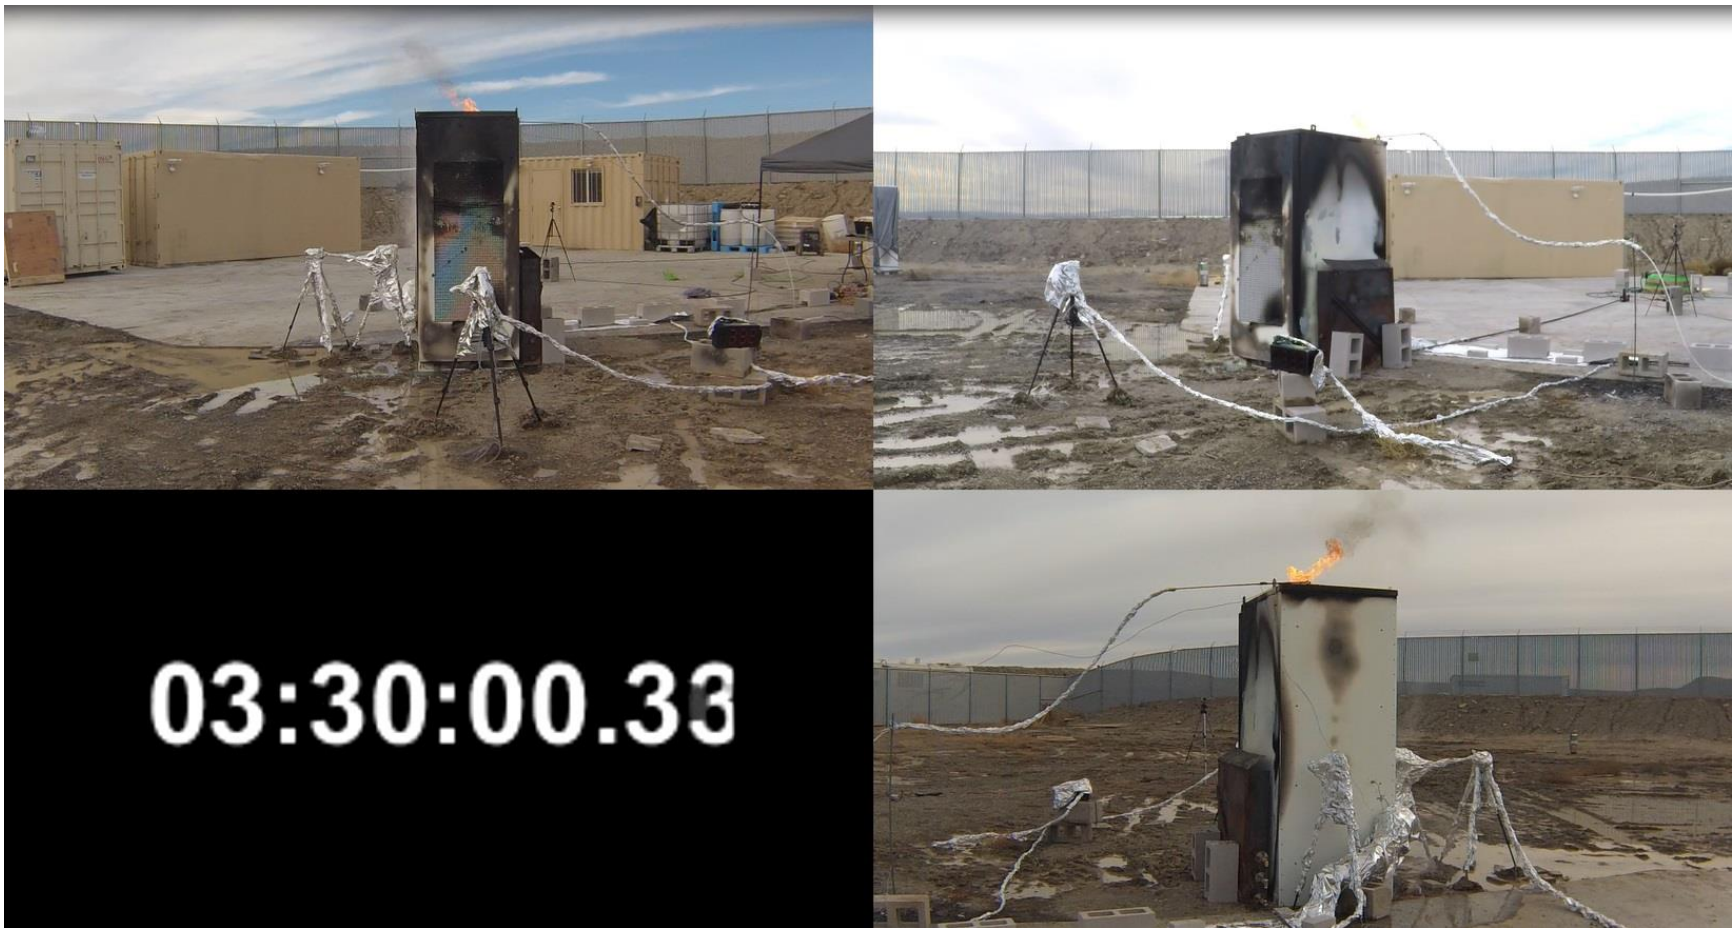
Figure 27 External test screenshot: test time = 3 hours 30 minutes, fire inside the Powerpack burning itself out

3:10:50	Last pop heard from Powerpack
3:30:00	Fire continues to decrease in intensity
3:41:10	Last visible flame out
3:45:00	Cameras and data acquisition off

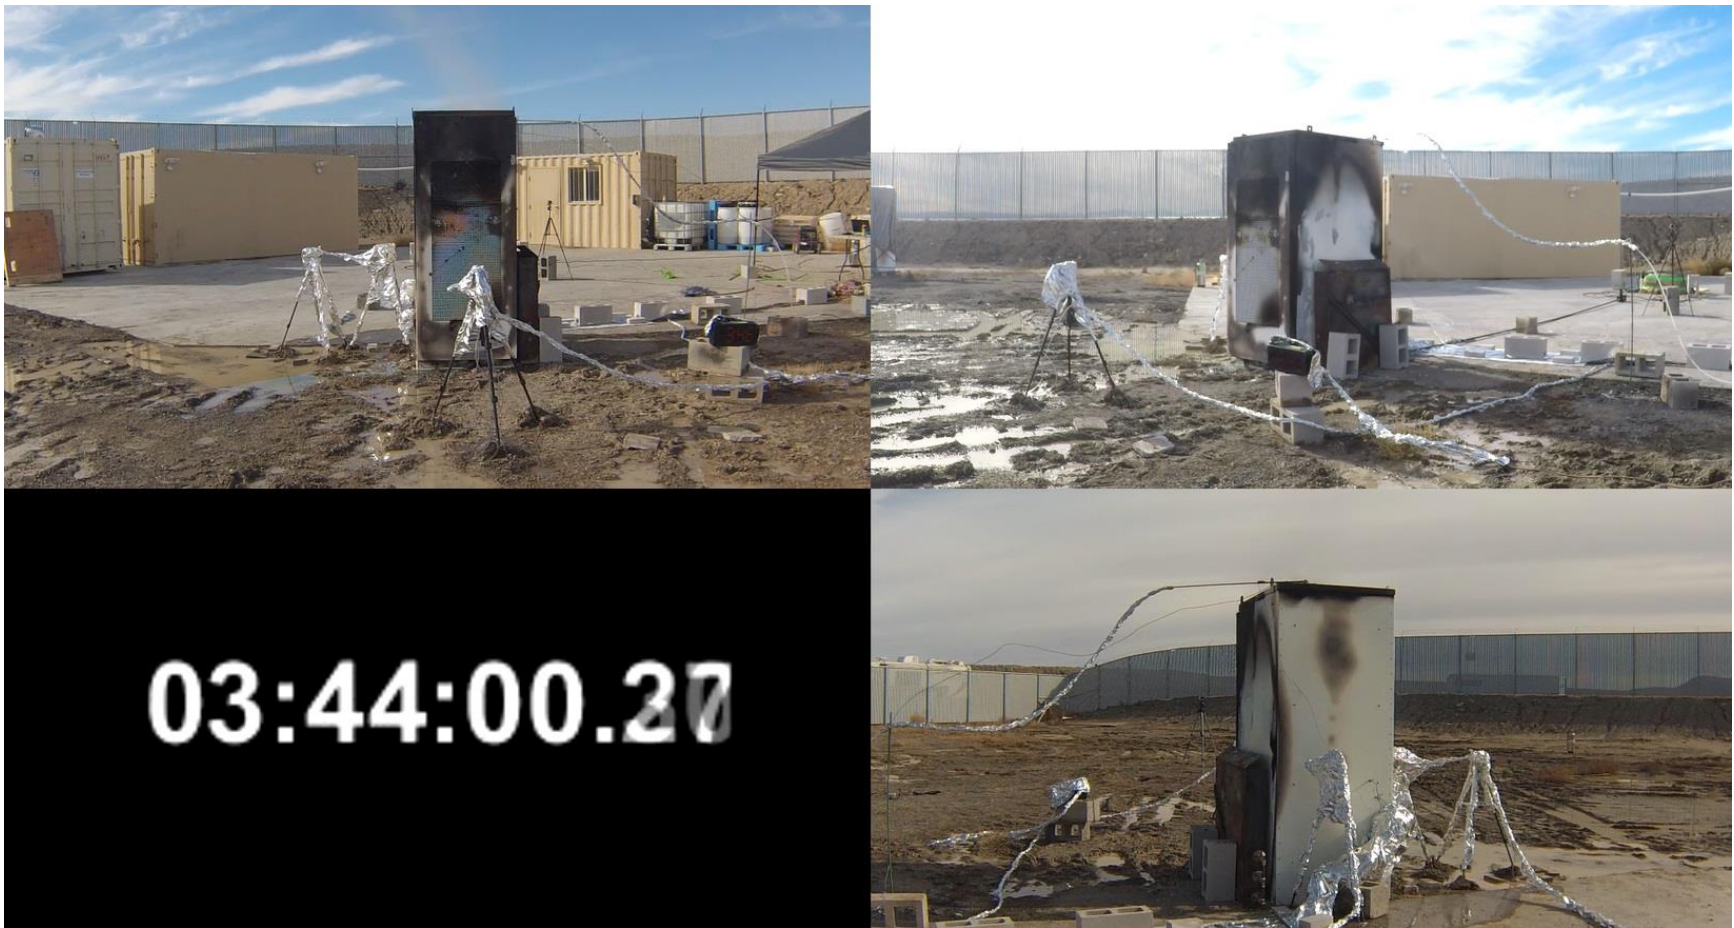
Figure 28 External test screenshot: end of test, fire is out.

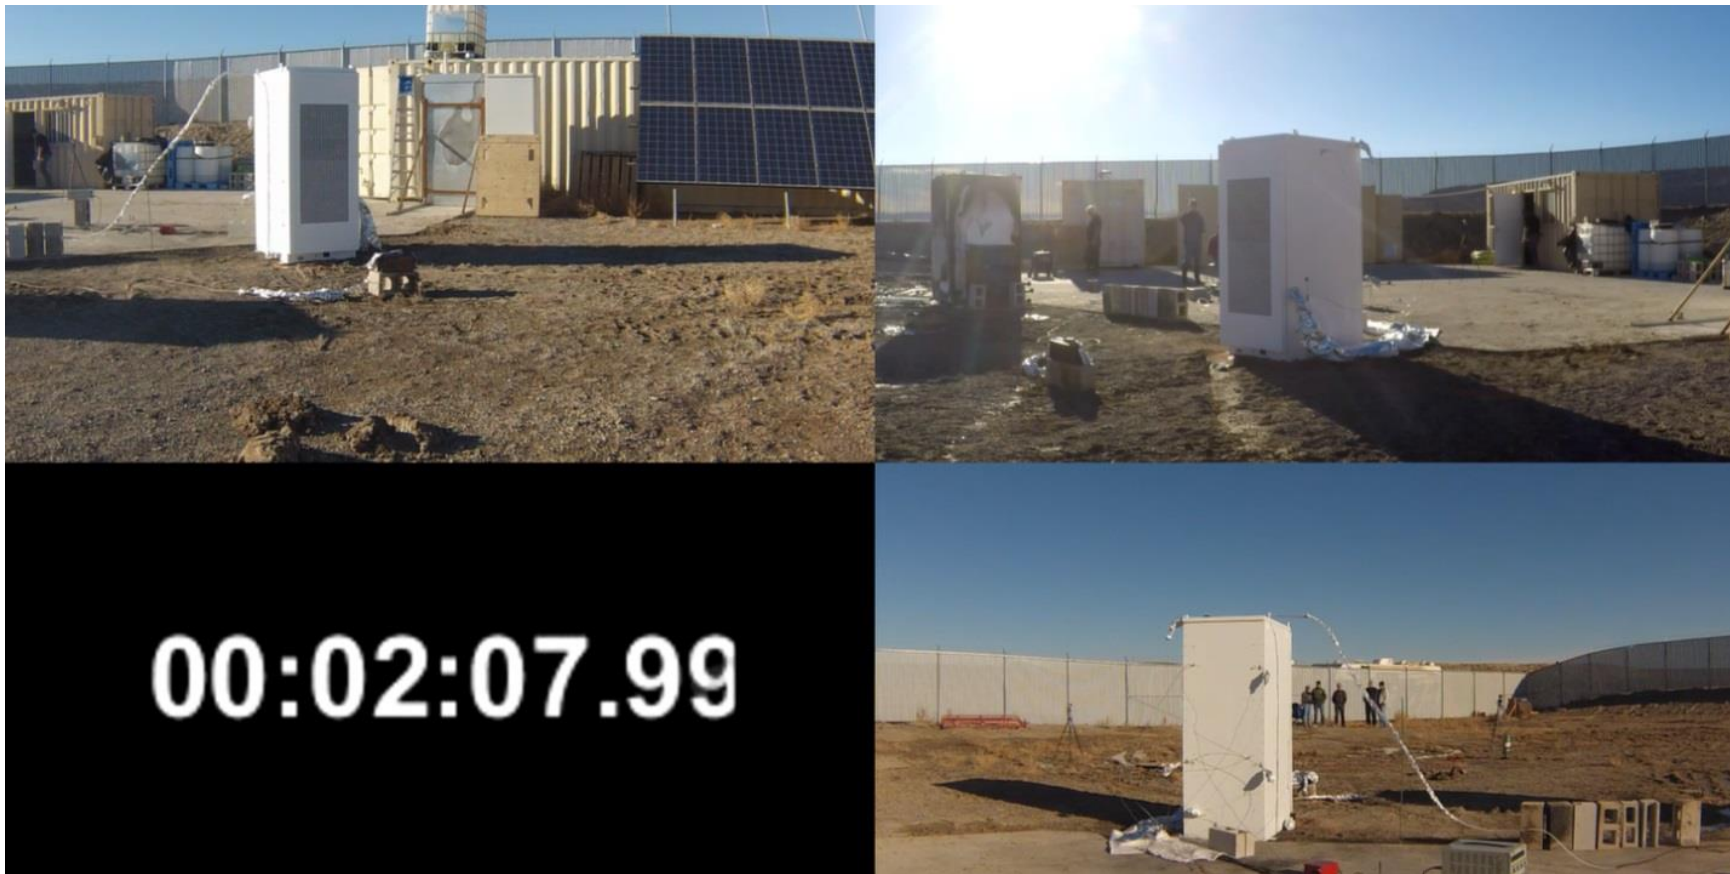
Figure 29 Internal test screenshot: start of test, heater cartridges "ON"

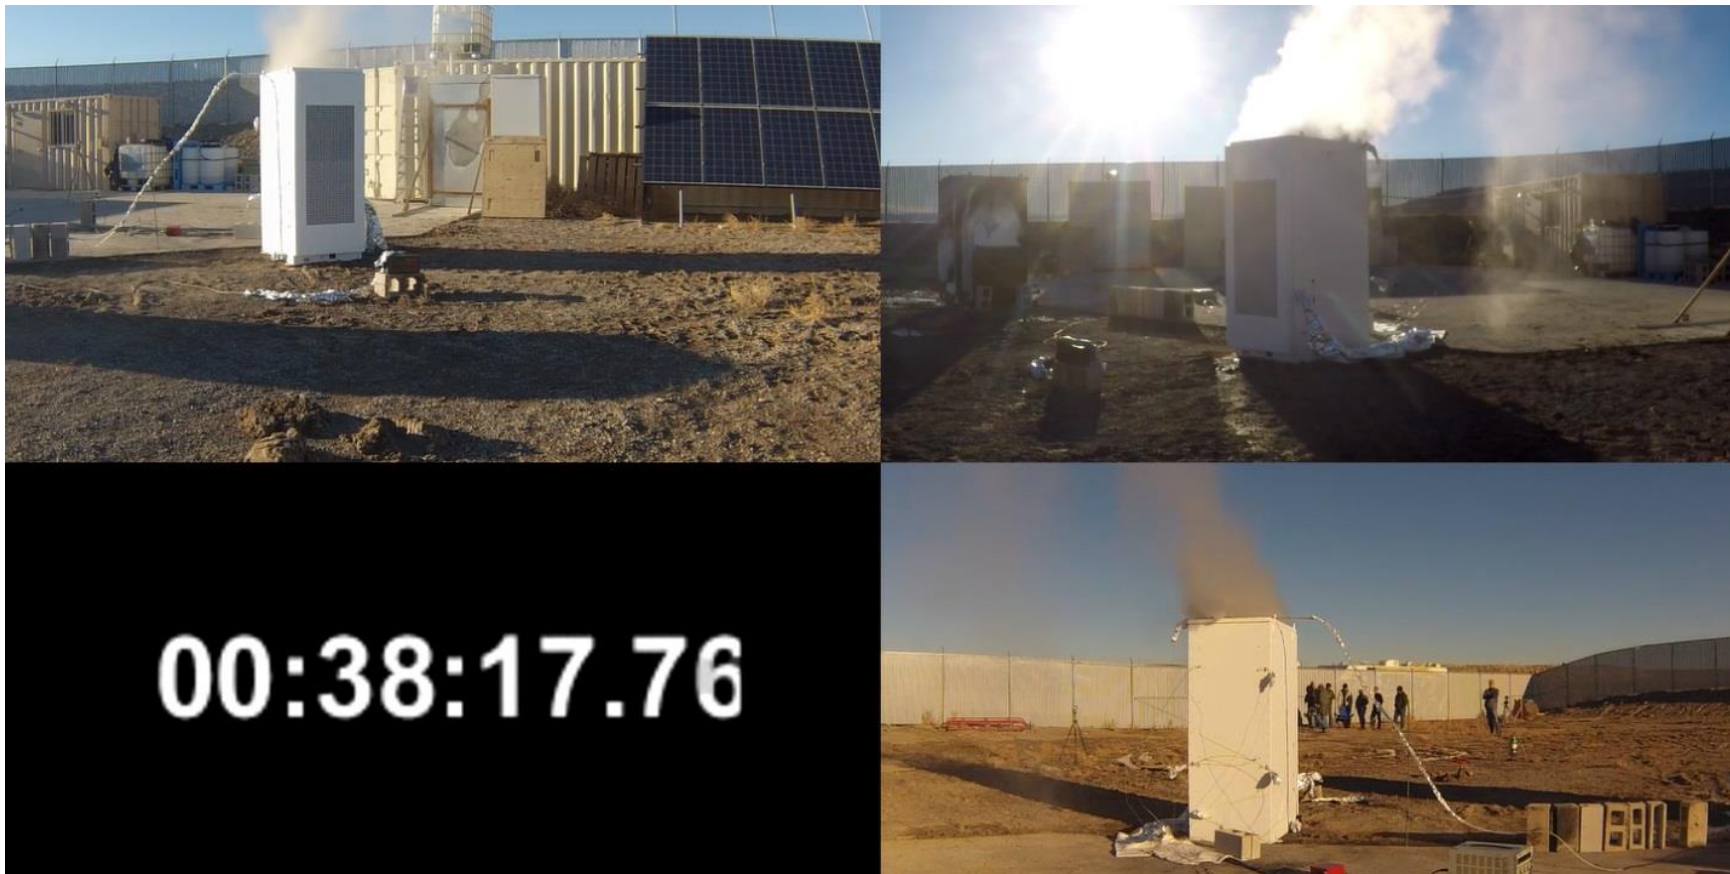
Figure 30 Internal test screenshot: peak smoke production approximately 35 to 40 minutes after the heater cartridges were turned “ON”

0:36:22	Steady pops heard from Powerpack starting at this time until 0:45:01 consistent with cell thermal runaway
0:38:34	Heater cartridges turned off.
0:45:01	Last pop heard from Powerpack

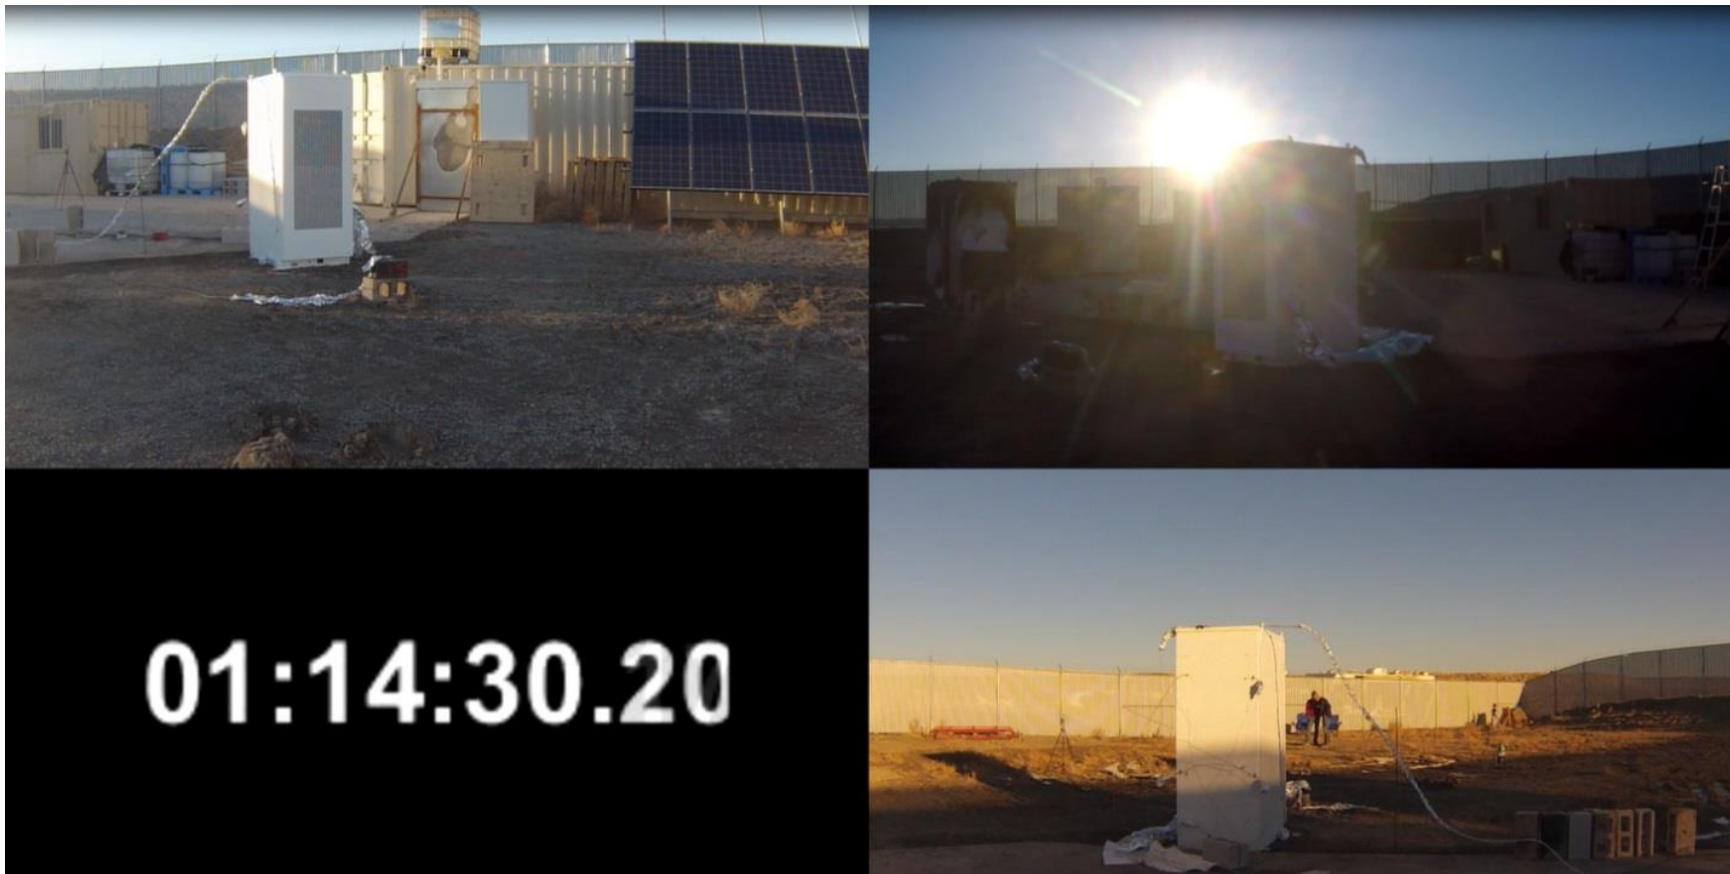
Figure 31 Internal test screenshot: end of test

0:49:30	Smoke production at exhaust vent subsiding
1:00:00	Smoke production at exhaust vent subsiding
1:15:00	Smoke production at exhaust vent subsiding
1:30:00	Smoke production at exhaust vent barely visible, cameras and data acquisition turned off, test terminated
